FROM THE FACTORY, THE FULL SIZE CHEVY REAR LAMP HARNESSES HAD TWO DIFFERENT WIRE INDEXING CONFIGURATIONS ON THE MAIN CONNECTOR, SHOWN BELOW. NOTE THAT THE ONLY DIFFERENCE IS THAT THE WIRE COLOR INDEXING IS 180 DEGREES OFF ON ONE VERSION VERSUS THE OTHER.

12-03-10 A ADDED TO 1967 CHEVY REAR

LAMP HARNESS

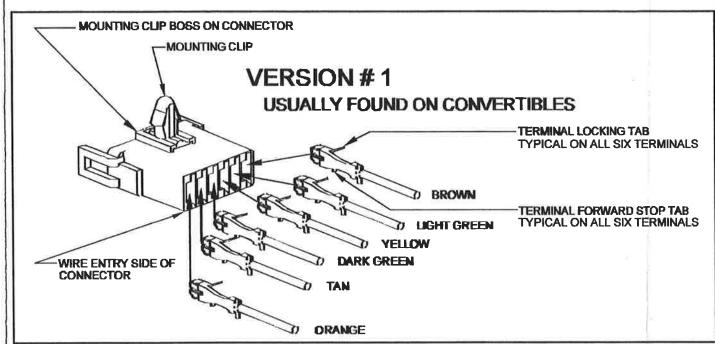
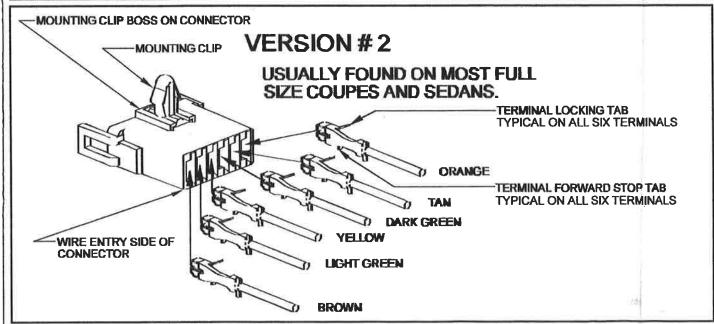
ARRANGE CONNECTOR WITH MOUNTING
 CLIP FACING UP, SO THAT YOU ARE VIEWING

THE WIRE ENTRY SIDE OF THE NEW

CONNECTOR.

2. AS EACH TERMINAL WIRE IS INSERTED, BE SURE NOT TO CONFUSE THE LOCKING TAB WITH THE FORWARD STOP TAB OF THE TERMINAL.

- 3. INSERT EACH WIRE INTO THE CONNECTOR AS ILLUSTRATED TO THE LEFT.
- 4. LISTEN AND FEEL FOR THE CLICK AS EACH TERMINAL IS INSERTED INTO THE CONNECTOR CAVITY. GENTLY TUG ON THE WIRE WHEN THE CLICK IS HEARD TO BE SURE THE TERMINAL IS FULLY LOCKED IN PLACE.
- 5. ONCE ALL TERMINALS ARE LOCKED INTO THE CONNECTOR CORRECTLY, COMPARE THE NEW HARNESS CONNECTION TO THE EXISTING ONE. THESE SHOULD NOW BE IDENTICAL. NOW THE INSTALLATION OF THE REAR LAMP HARNESS CAN BE COMPLETED.
